PROJECT NUMBER & NAME: C-DRC2026-00014 - Minor Use Permit / Coastal Development Permit - Pacific Pines HOA

**PROJECT DESCRIPTION:** A request by the Pacific Pines Home Owner's Association for a Minor Use Permit / Coastal Development Permit (C-DRC2026-00014) to authorize the repair and expansion of existing drainage infrastructure. The project is in the Residential Single-Family land use category, located at APN: 013-124-022 in the Community of Cambria, approximately 400 feet northeast of the intersection of Ramsey Street and Skye Street. The project is in the North Coast Planning Area of the Coastal Zone

**PACIFIC PINES  
DRAINAGE IMPROVEMENTS PROJECT  
CAMBRIA, SAN LUIS OBISPO COUNTY, CA  
(Portion of Assessor's Parcel Number 013-124-022)  
BIOLOGICAL RESOURCES ASSESSMENT**

PACIFIC PINES HOA EROSION REPAIR

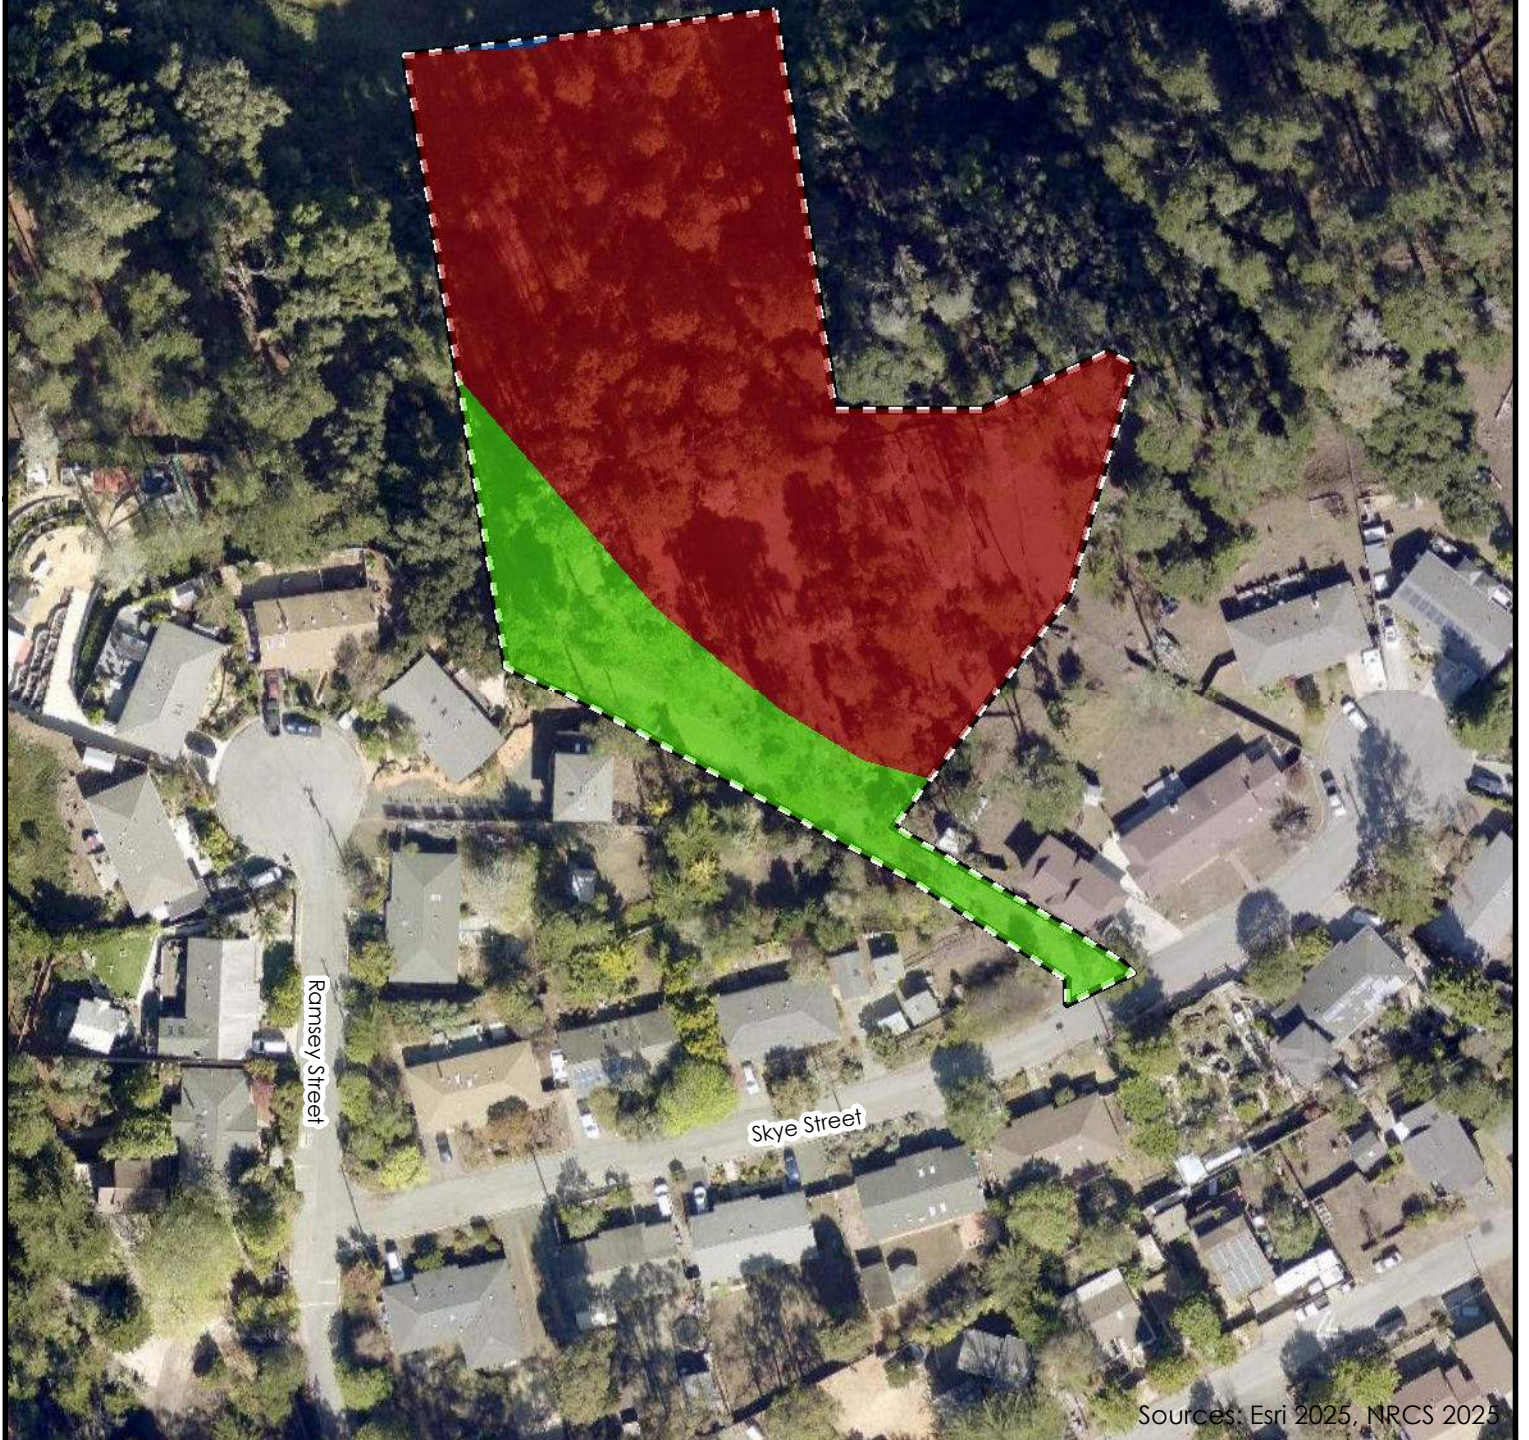
San Simeon sandy loam, 30 to 50 percent slopes

Sources: Esri 2025, NRCS 2025

overview map with wetland habitats recorded in the NWI. Figure 3 is a soils map and Figure 4 is a habitat map of the study area showing the area occupied by each of the habitat types. Figures 5 and 6 show the locations of special-status plant and animal species, respectively, recorded in the CNDDDB within five miles of the study area. Designated critical habitat and sensitive natural communities are shown in Figure 7.

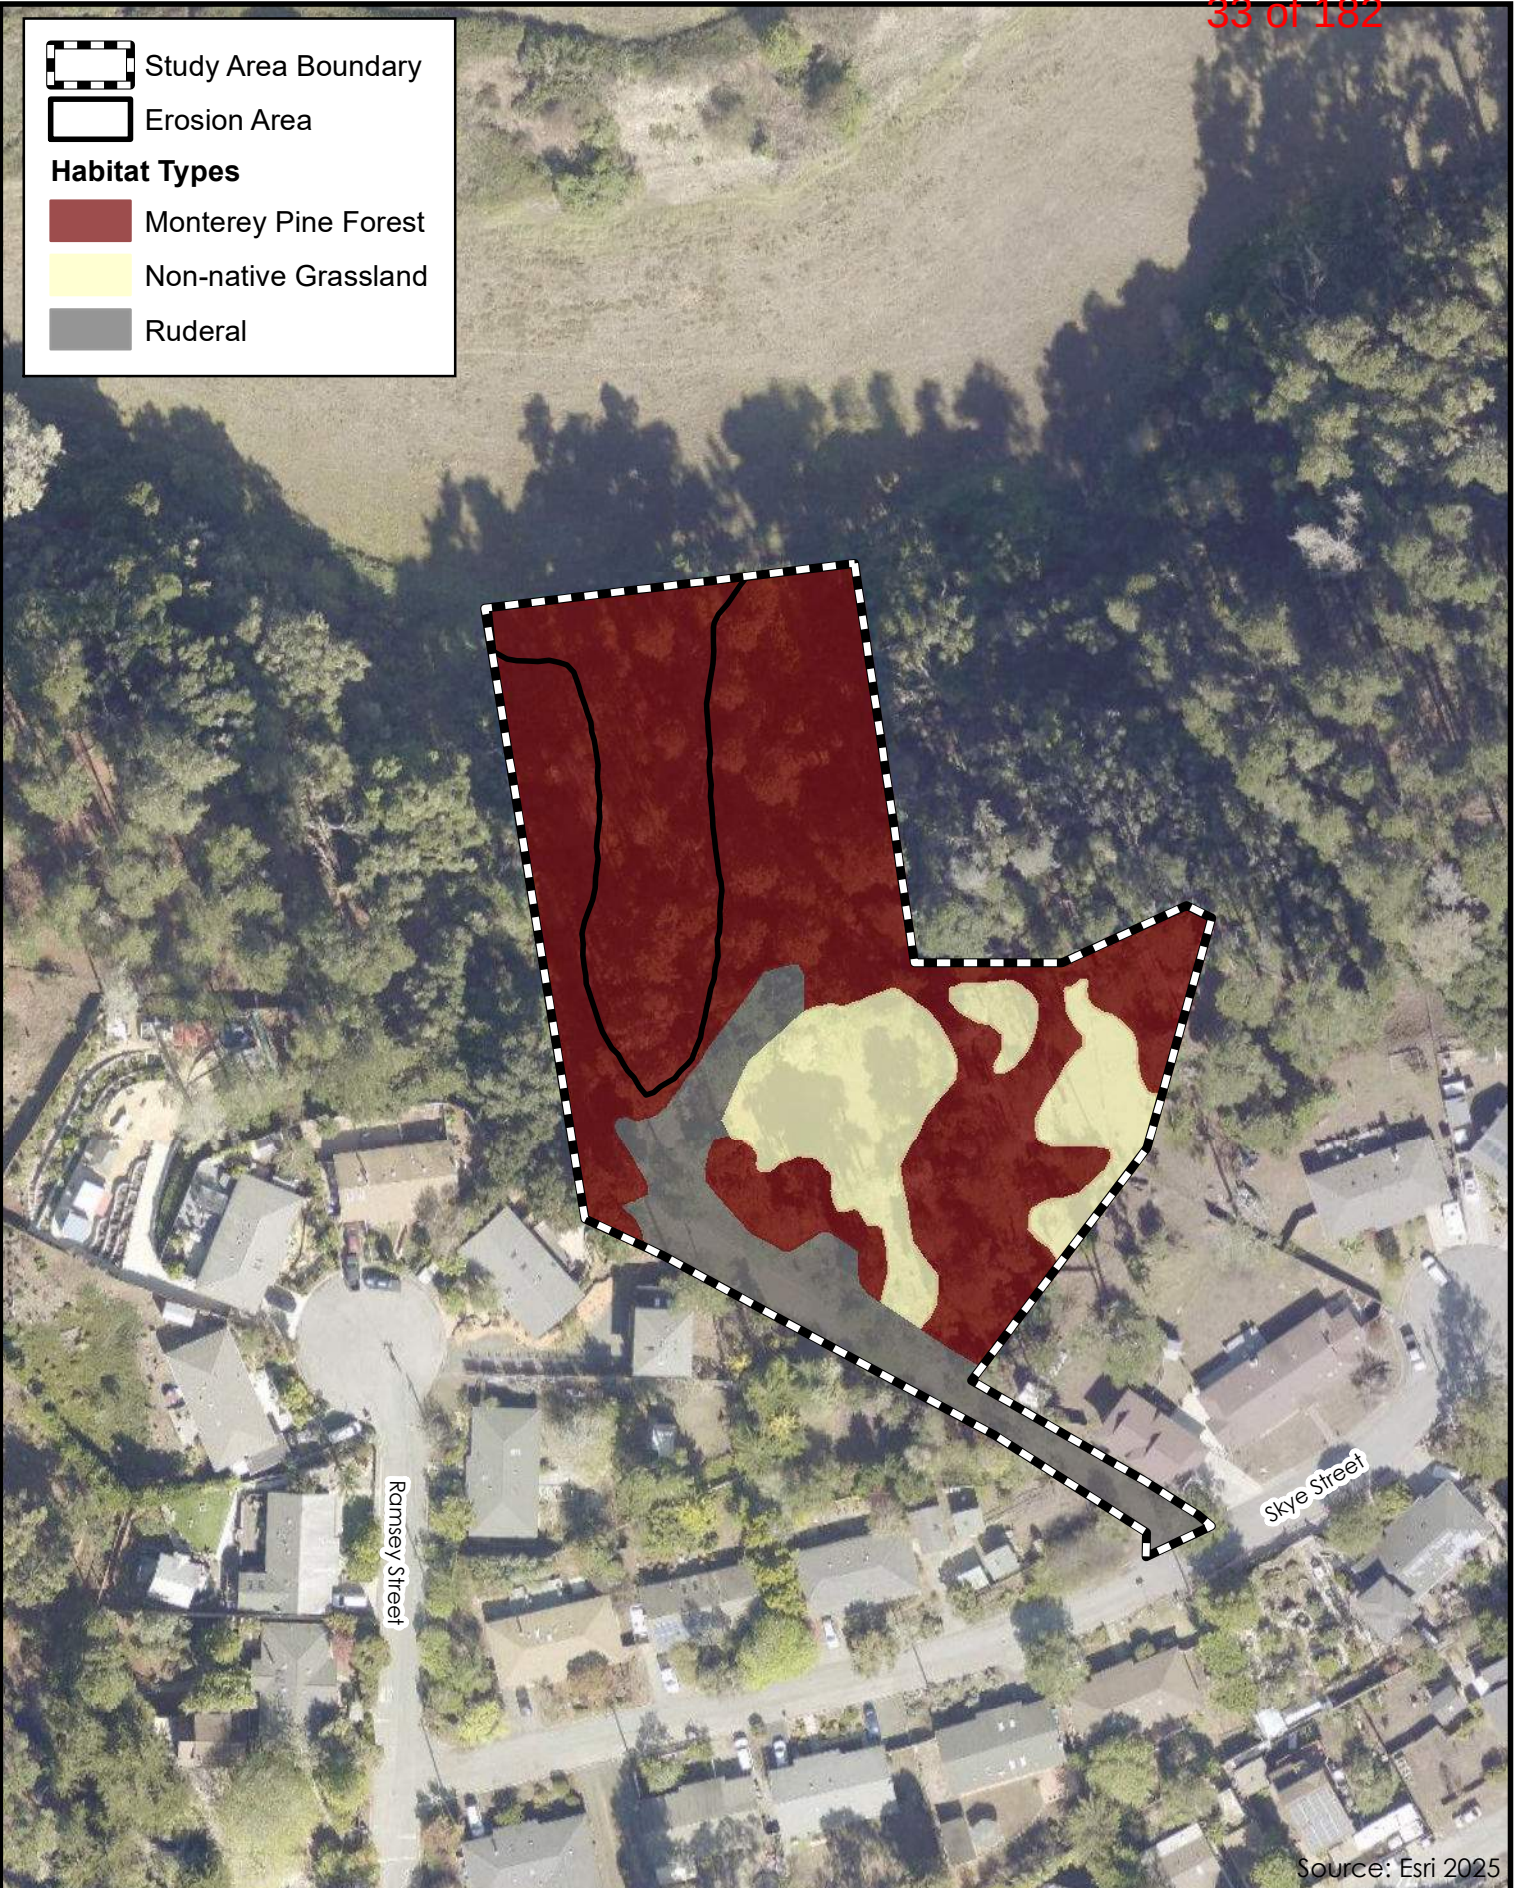
Ruderal

Source: Esri 2025

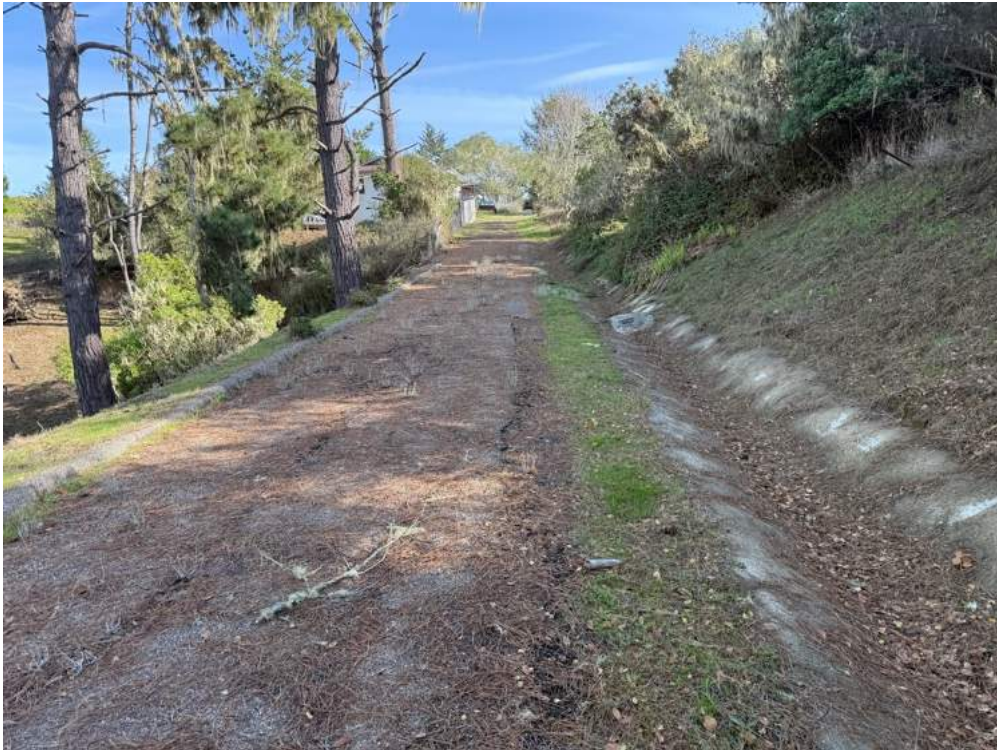
**Photo 1.** Southeasterly view of an old asphalt road onsite that accesses Skye Street, and a concrete stormwater swale along the road.

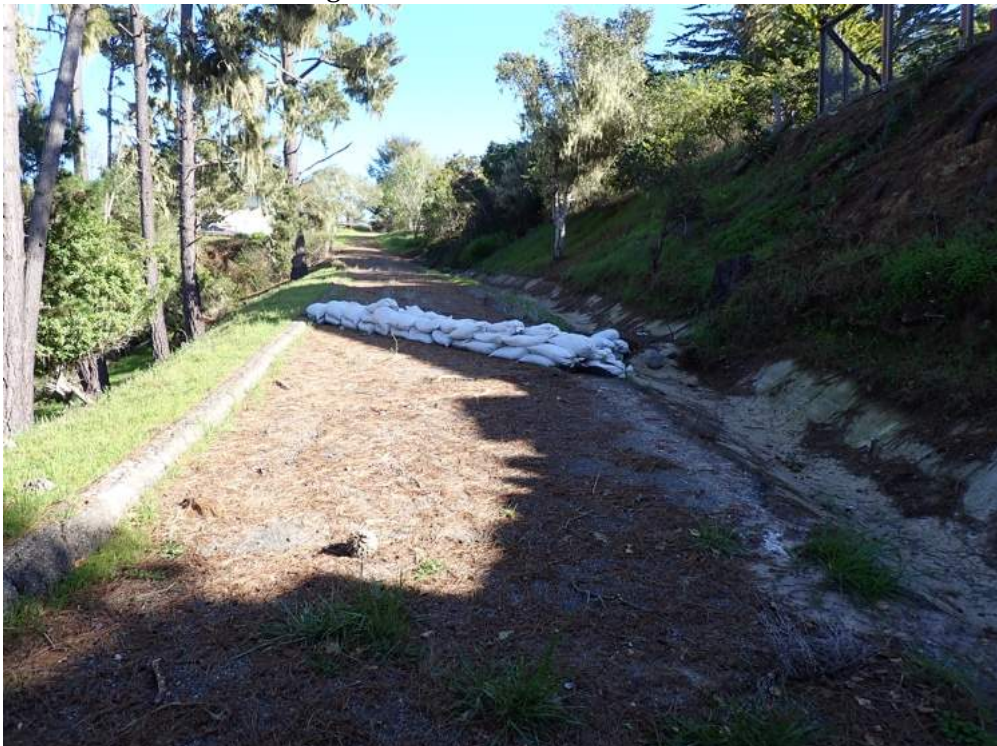
**Photo 2.** View of sandbags used to direct road runoff into the swale as part of the interim erosion control efforts.

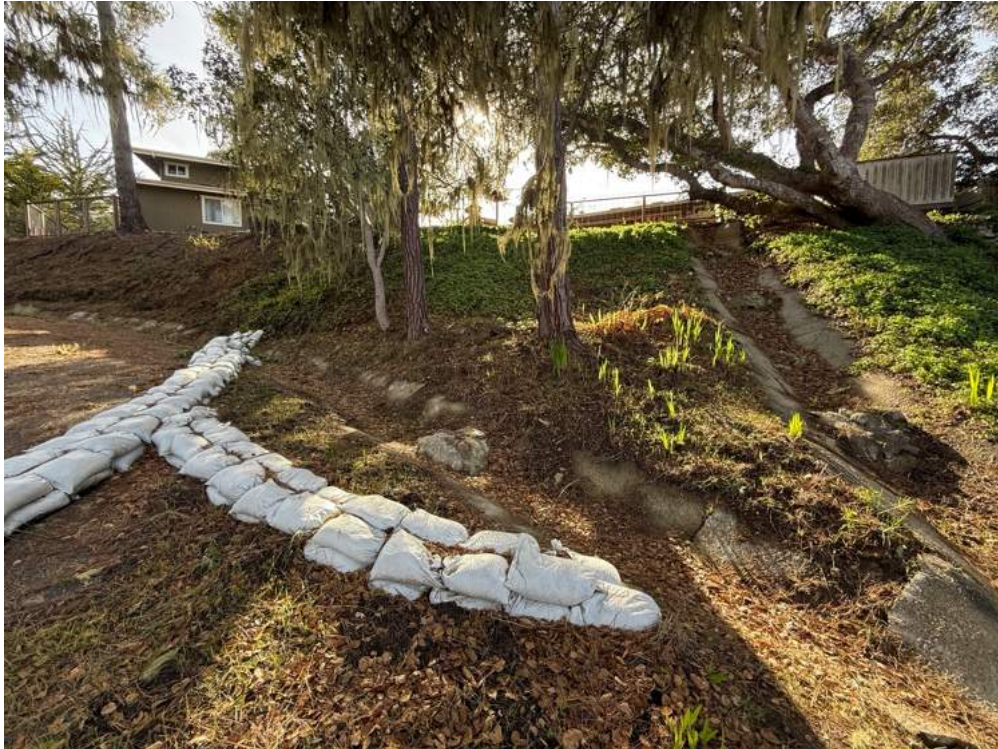
**Photo 3.** The concrete-lined swales direct surface runoff down the lower slope seen in the right bottom corner to a culvert and storm drain pipe on the steep slope.

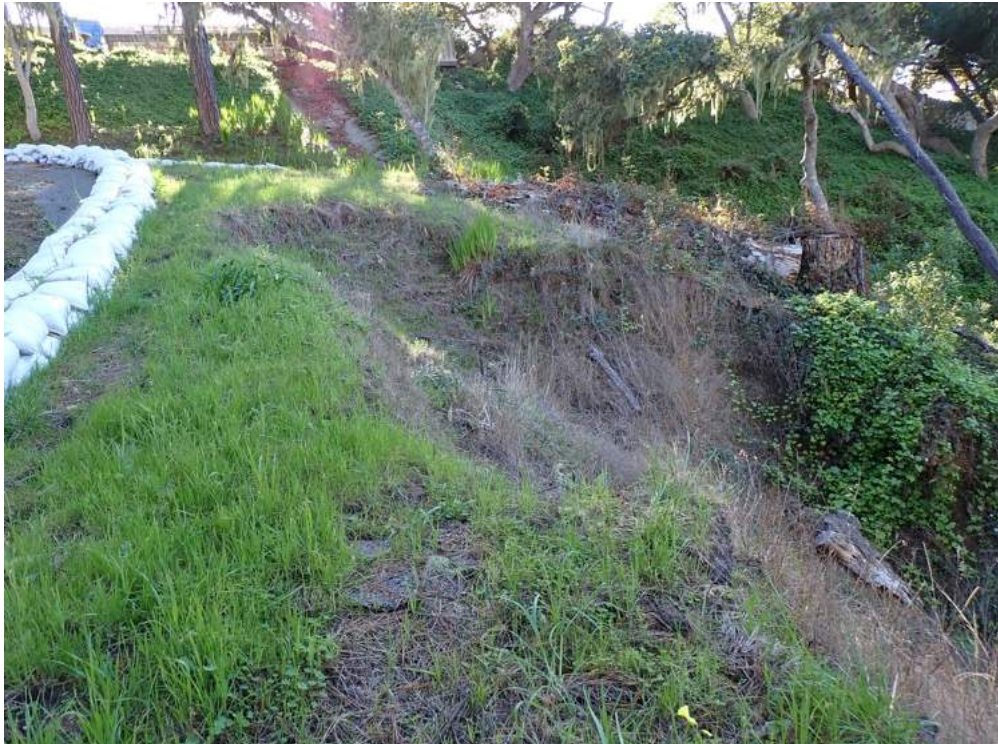
**Photo 4.** During winter 2022-2023, surface runoff down the road bypassed the drainage structures and eroded the hillside below the road.

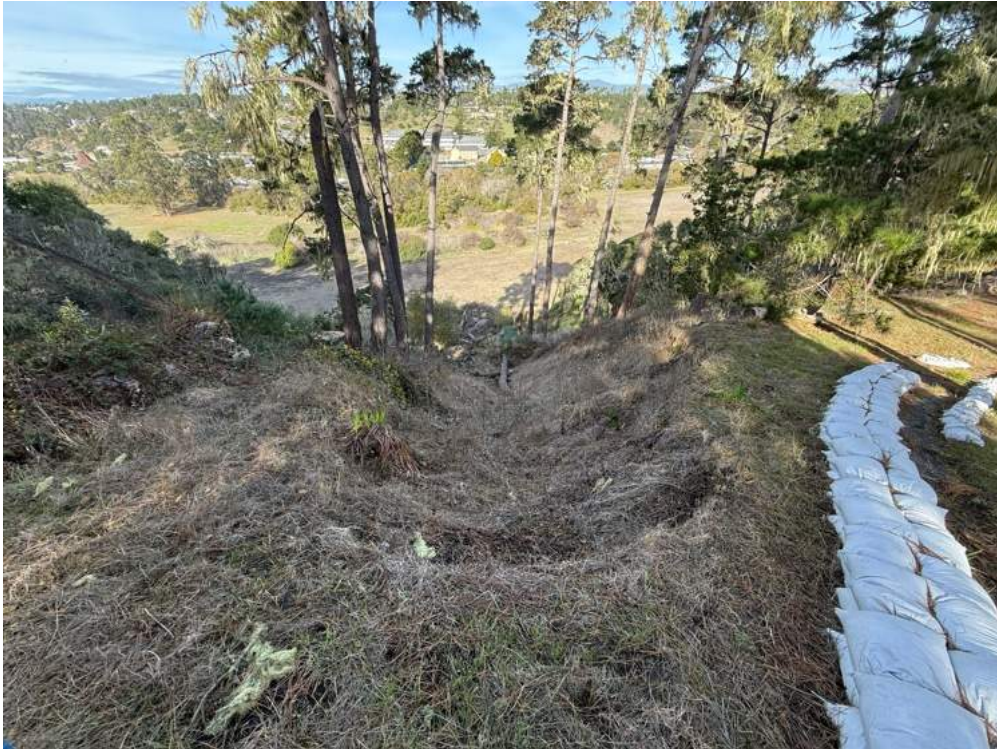
**Photo 5.** Northerly view of the eroded gully below the old road that is becoming revegetated by a mix of non-native and native plants.

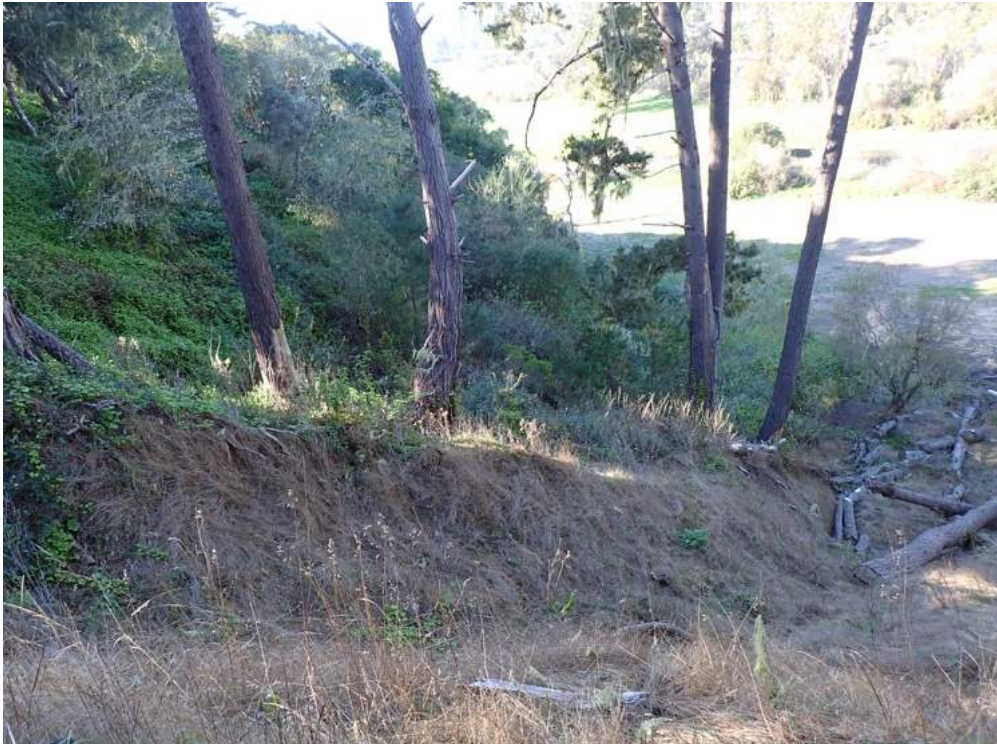
**Photo 6.** Another view of the erosion area showing existing vegetation. Remnant tree trunks that were in the erosion area are visible near the toe of slope on the far right.

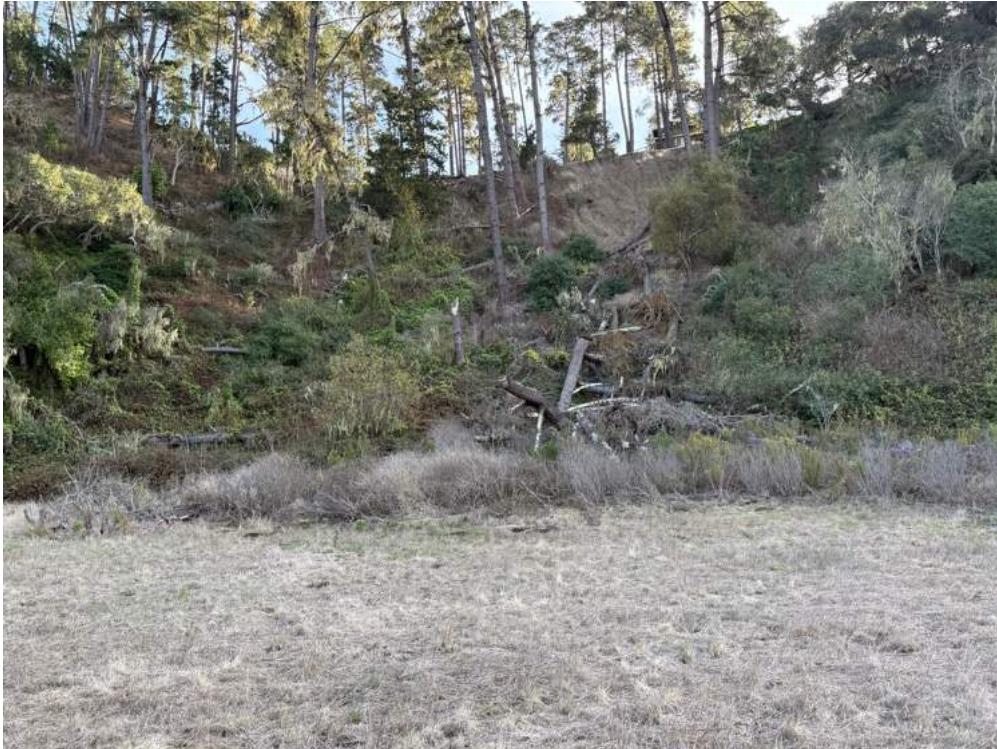
**Photo 7.** Southerly view of the steep slope from the Fiscalini Ranch Preserve showing the erosion scar and surrounding vegetation.

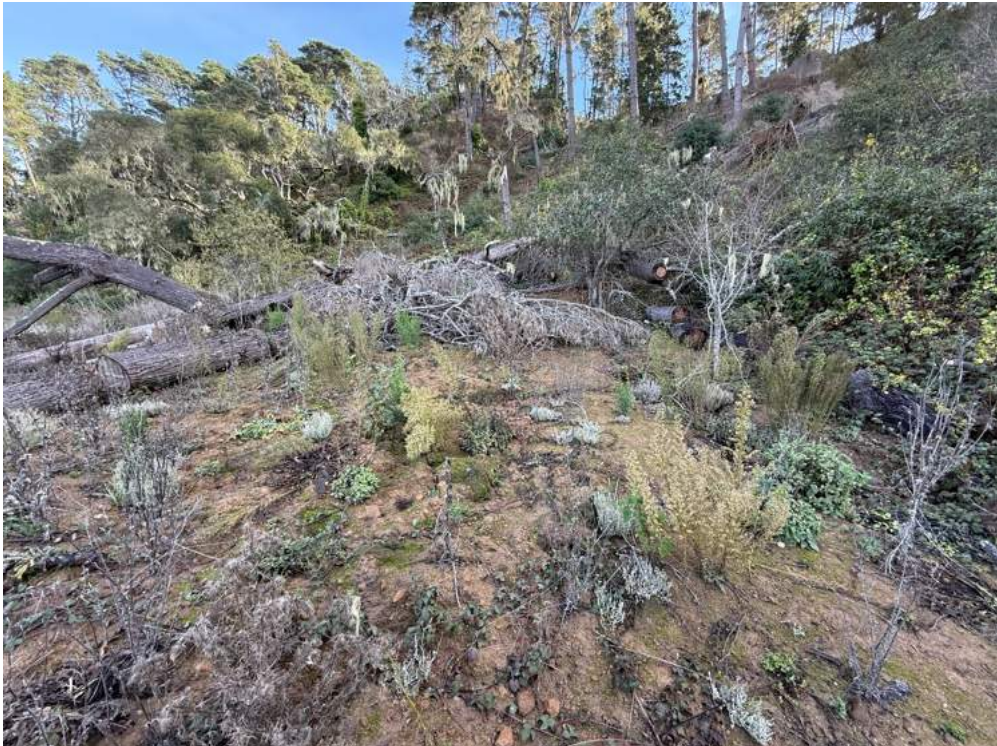
**Photo 8.** View of soils that accumulated at the base of the slope following the erosion event, and is now becoming revegetated with a mix of native and non-native species.

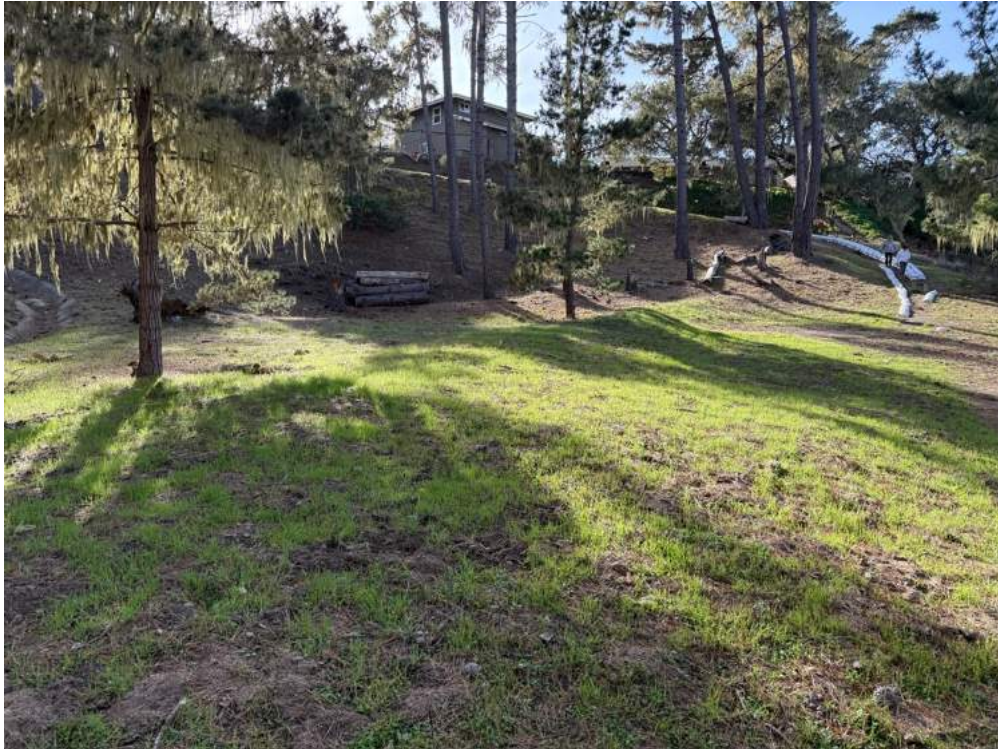
**Photo 9.** Southeasterly view meadow area in the middle of the study area. The mid- to upper slopes are a bowl-shaped feature that was graded and maintained to create a park-like setting. While Monterey pine trees are present, the understory is primarily non-native grasses that are regularly mowed.

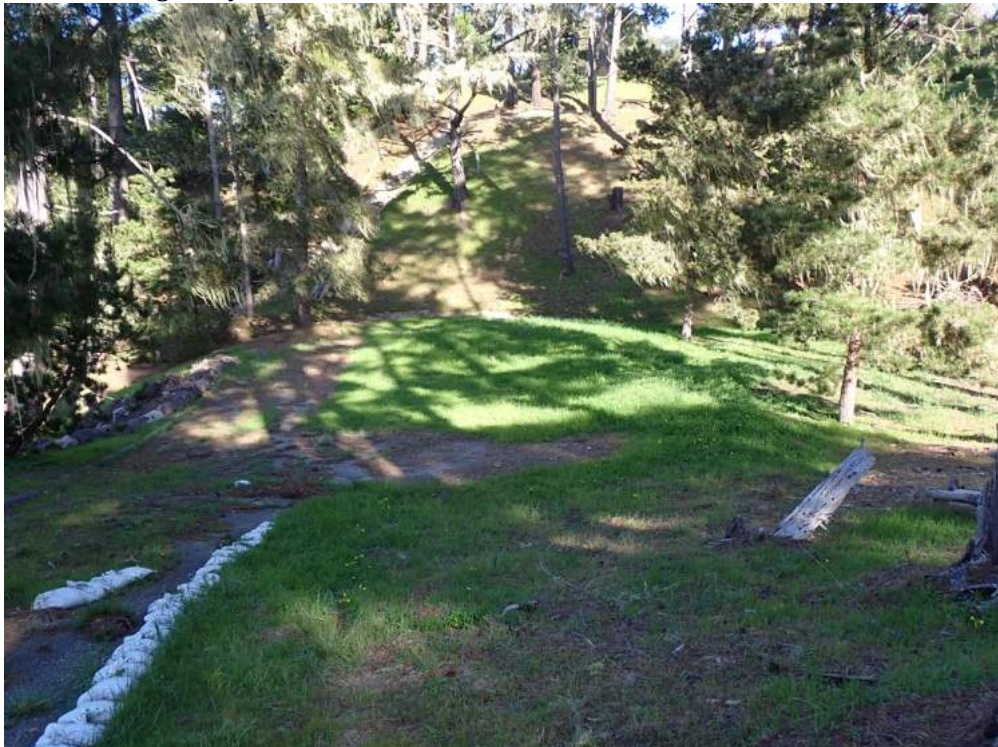
**Photo 10.** The old asphalt road terminates on this constructed bench half-way down the slope.

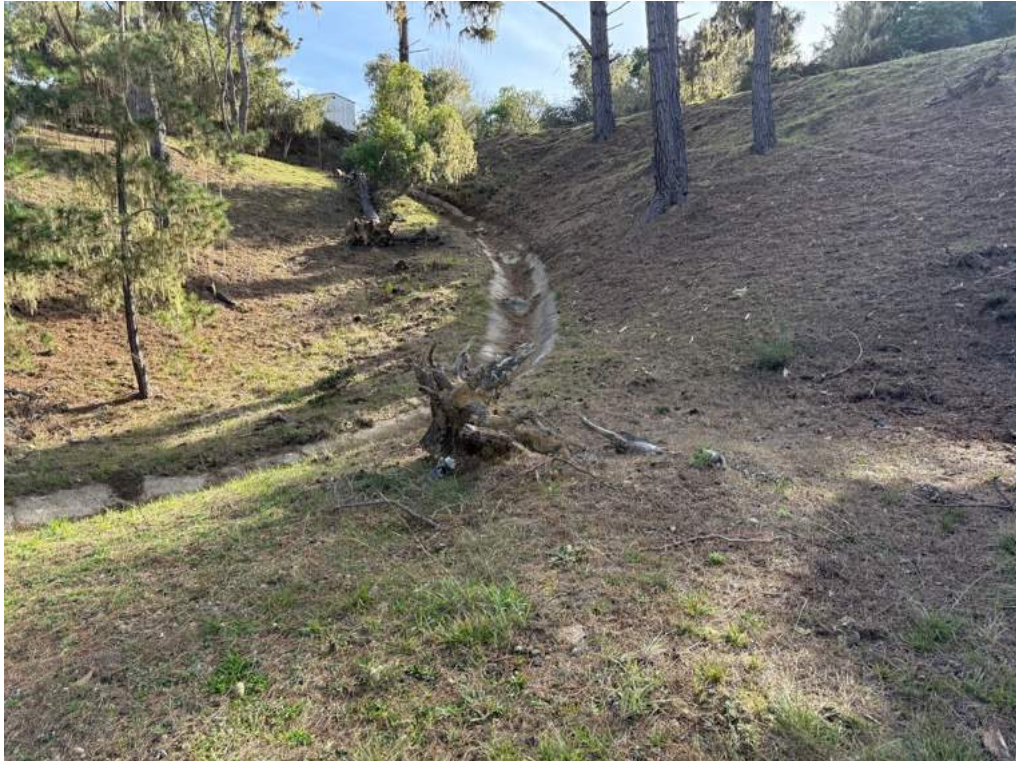
**Photo 11.** Representative view of concrete swales constructed on the site to direct stormwater runoff from the residential area along Skye Street down to lower bench area and storm drain pipe.

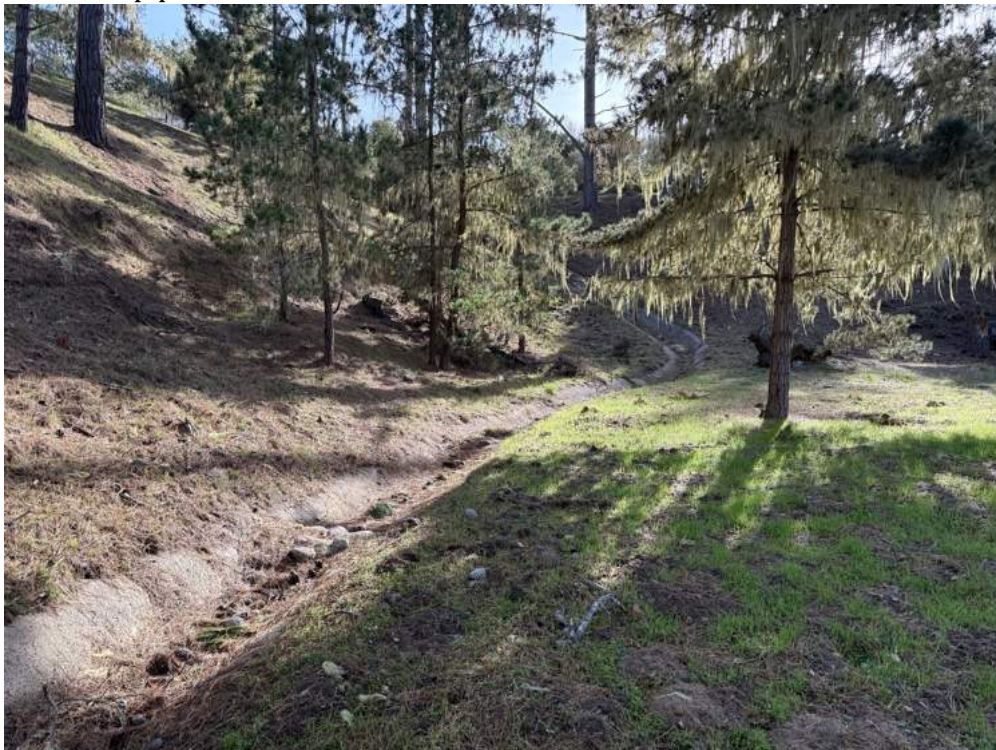
**Photo 12.** Additional view of concrete swales that direct stormwater from the upper slope to an existing storm drain pipe.

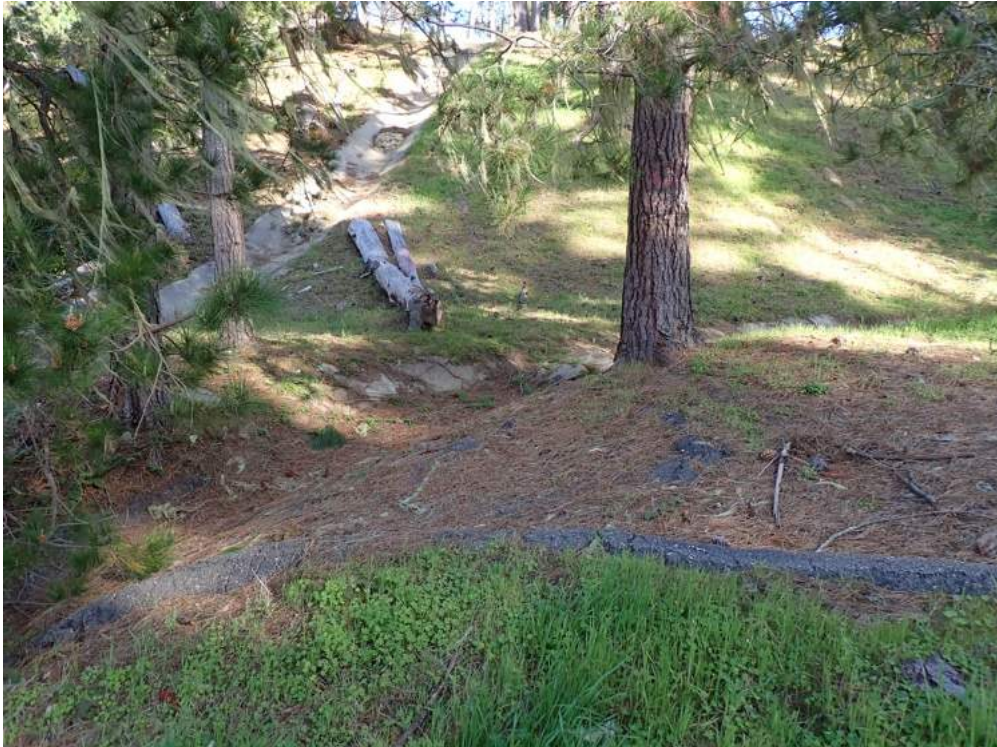
**Photo 13.** The concrete swales and asphalt curb converge in the eastern part of the bench to direct runoff into a storm drain pipe.

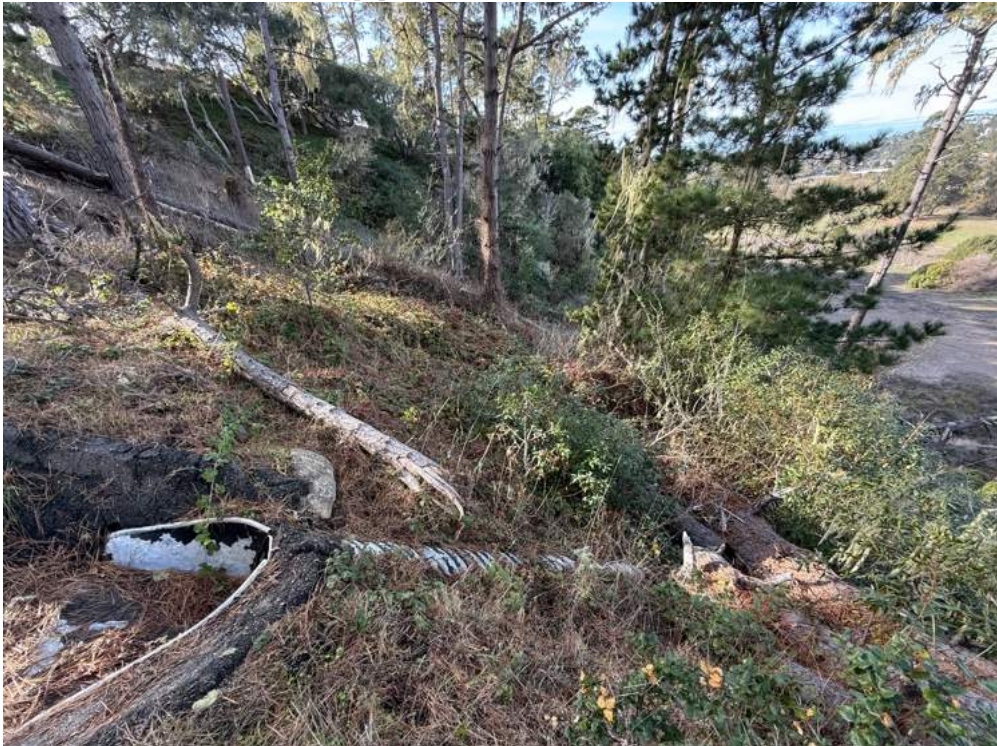
**Photo 14.** View of the storm drain pipe that carries surface runoff down to the lower slope and floodplain. The new, upsized storm drain pipe would be laid on the ground adjacent to this pipe, and vegetation impacts minimized.

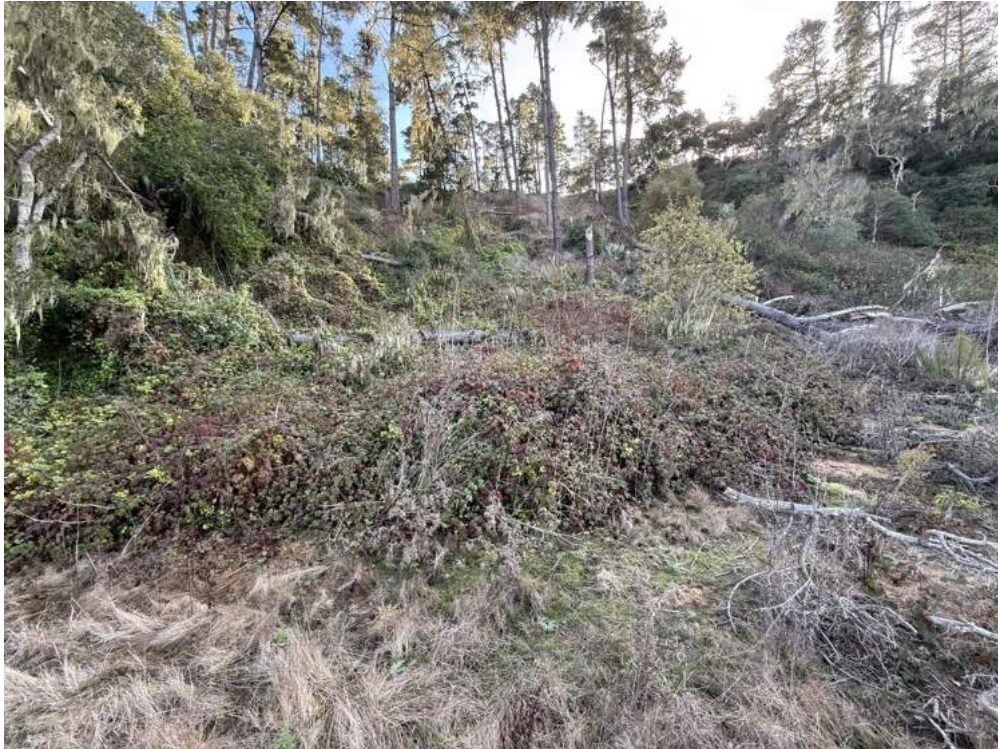
**Photo 15.** View of the lower slope showing dense vegetation with scattered Monterey pine and coast live oak trees. The storm drain pipe has been overgrown with understory plants.

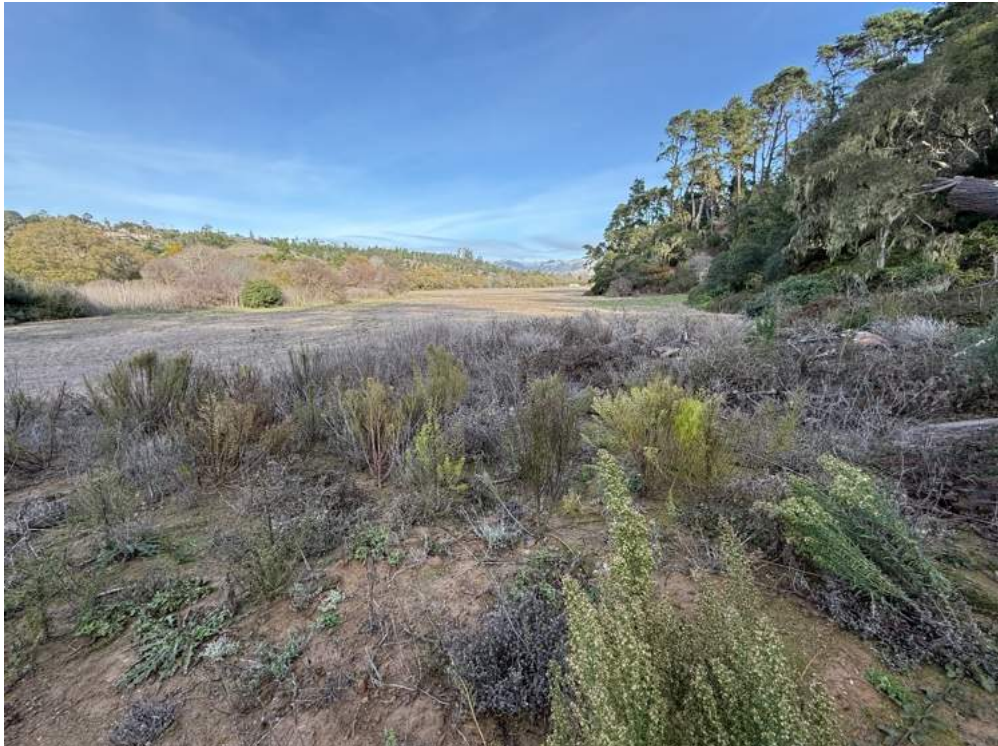
**Photo 16.** Northeasterly view of the Santa Rosa Creek floodplain taken from the base of the slope where eroded material was deposited. The study area is off to the right and Santa Rosa Creek is present to the far left.

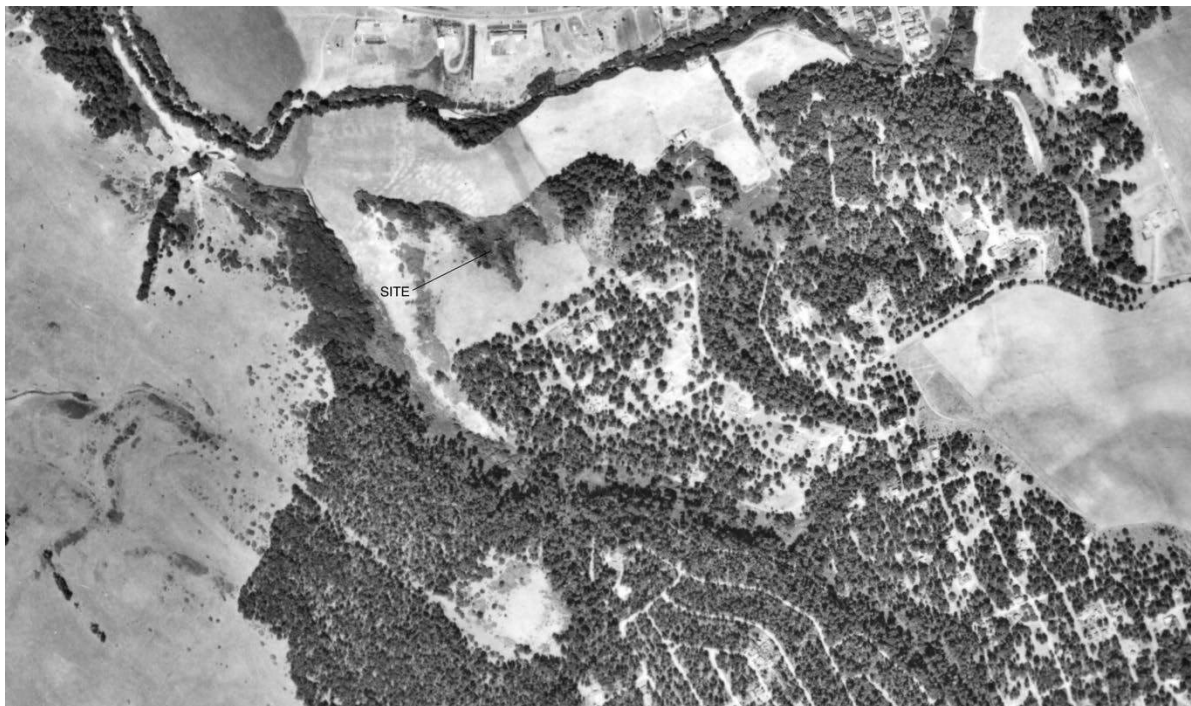
Figure 6: Historical Aerial Photograph (1956)
